PAVEMENT CAUSED FOD TO AIRCRAFT ENGINES

ABSTRACT

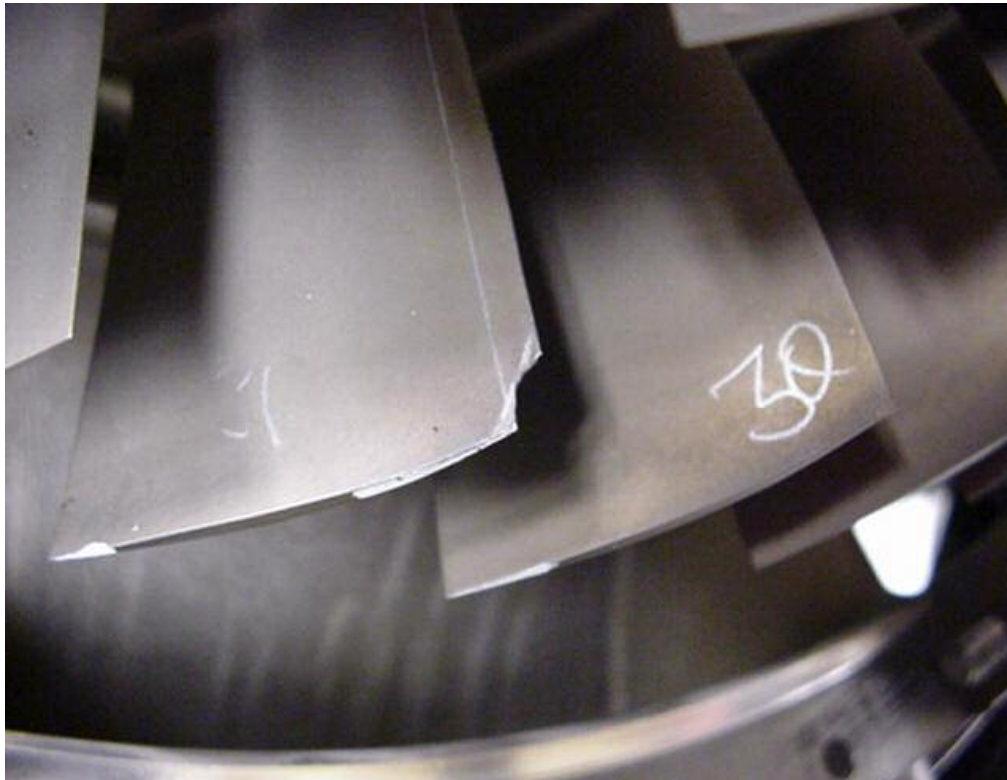
FIGURE 1 Example of a FOD damaged jet engine blade. (Courtesy of NAVAIR)

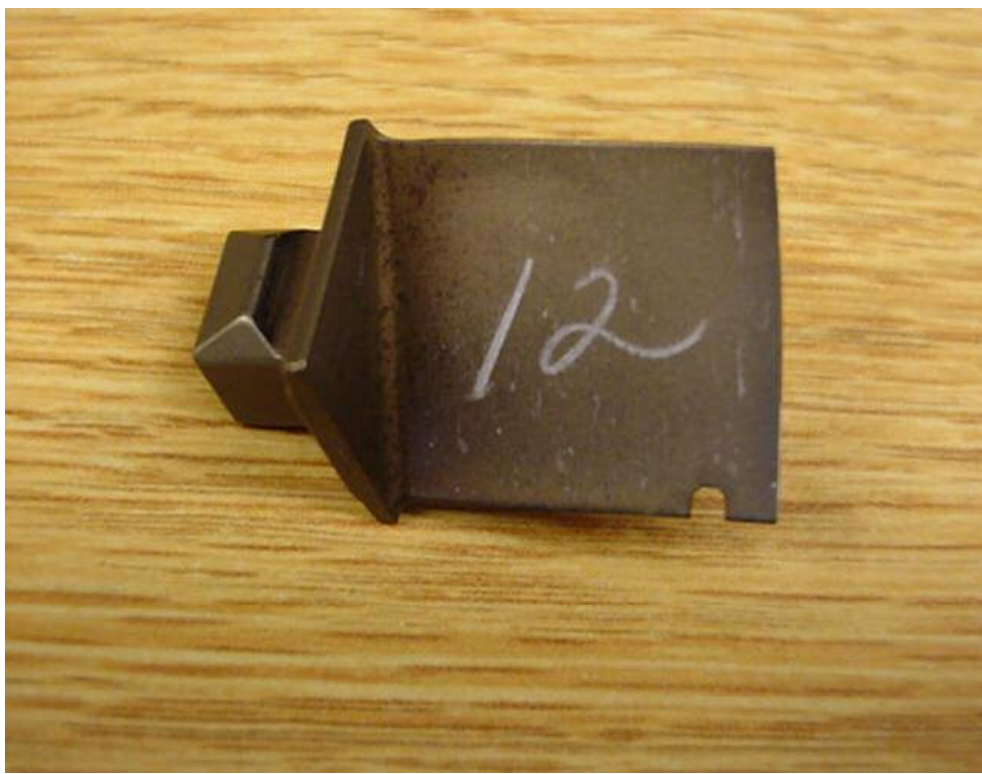
FIGURE 2 Suspected cause of damage is circular shaped object. (Courtesy of NAVAIR)

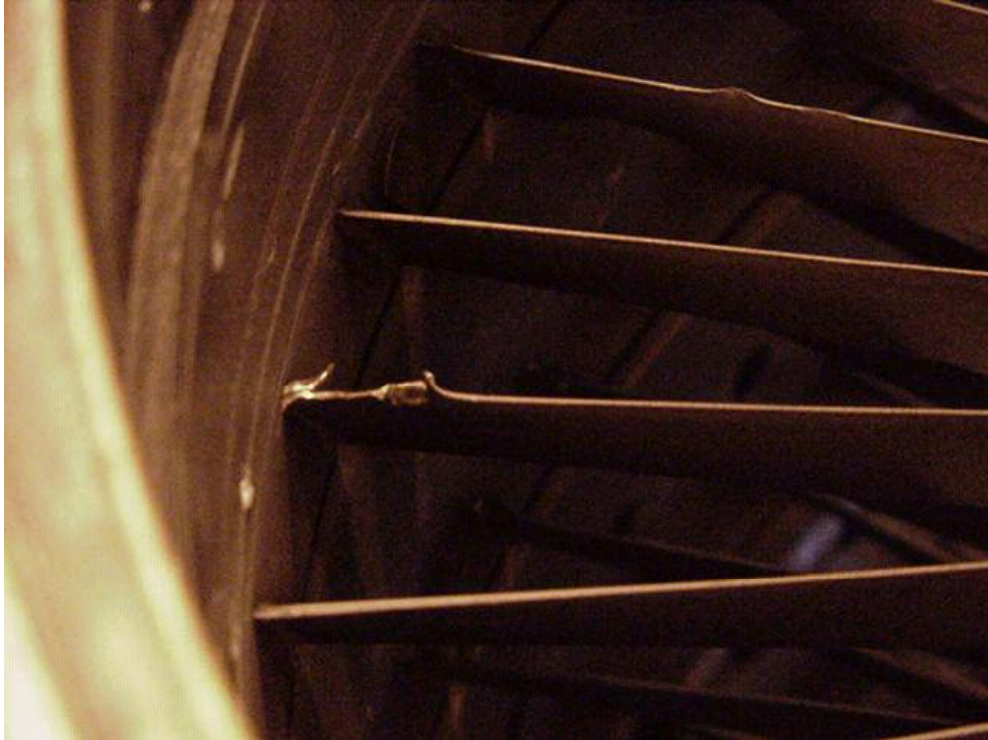
FIGURE 3 Example of damage caused by a fastener. (Courtesy of F.A.S.T.)

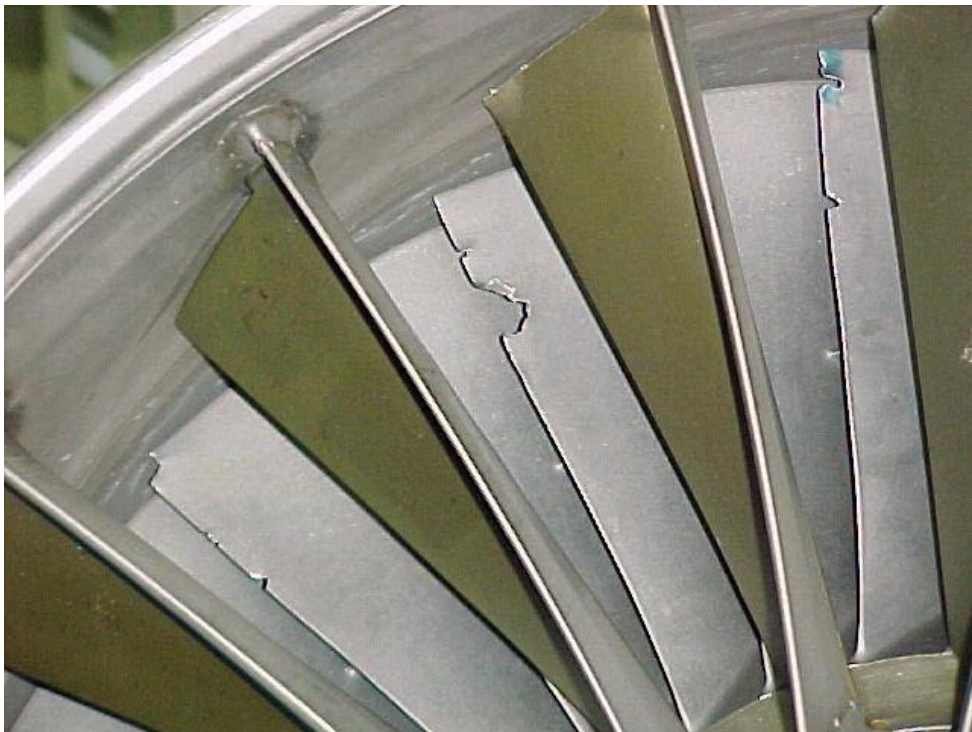
FIGURE 4 Example of damage caused by concrete. (Courtesy of F.A.S.T.)

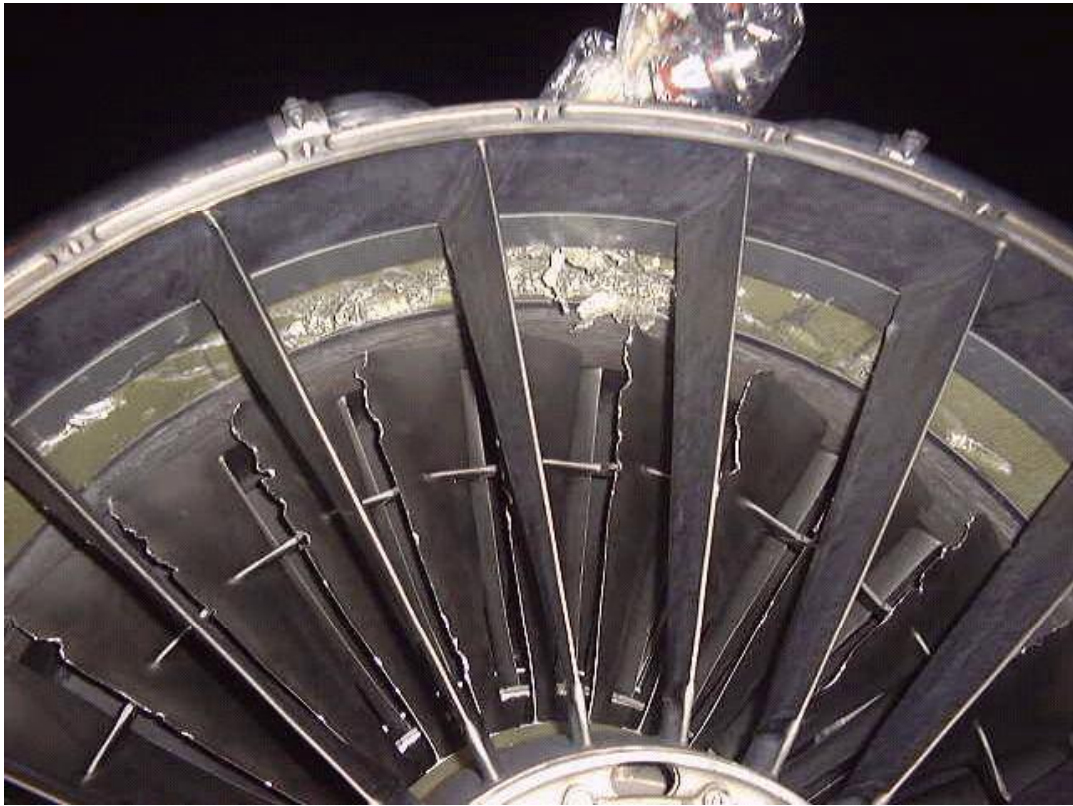
FIGURE 5 Example of damage caused by a tool. (Courtesy of F.A.S.T.)

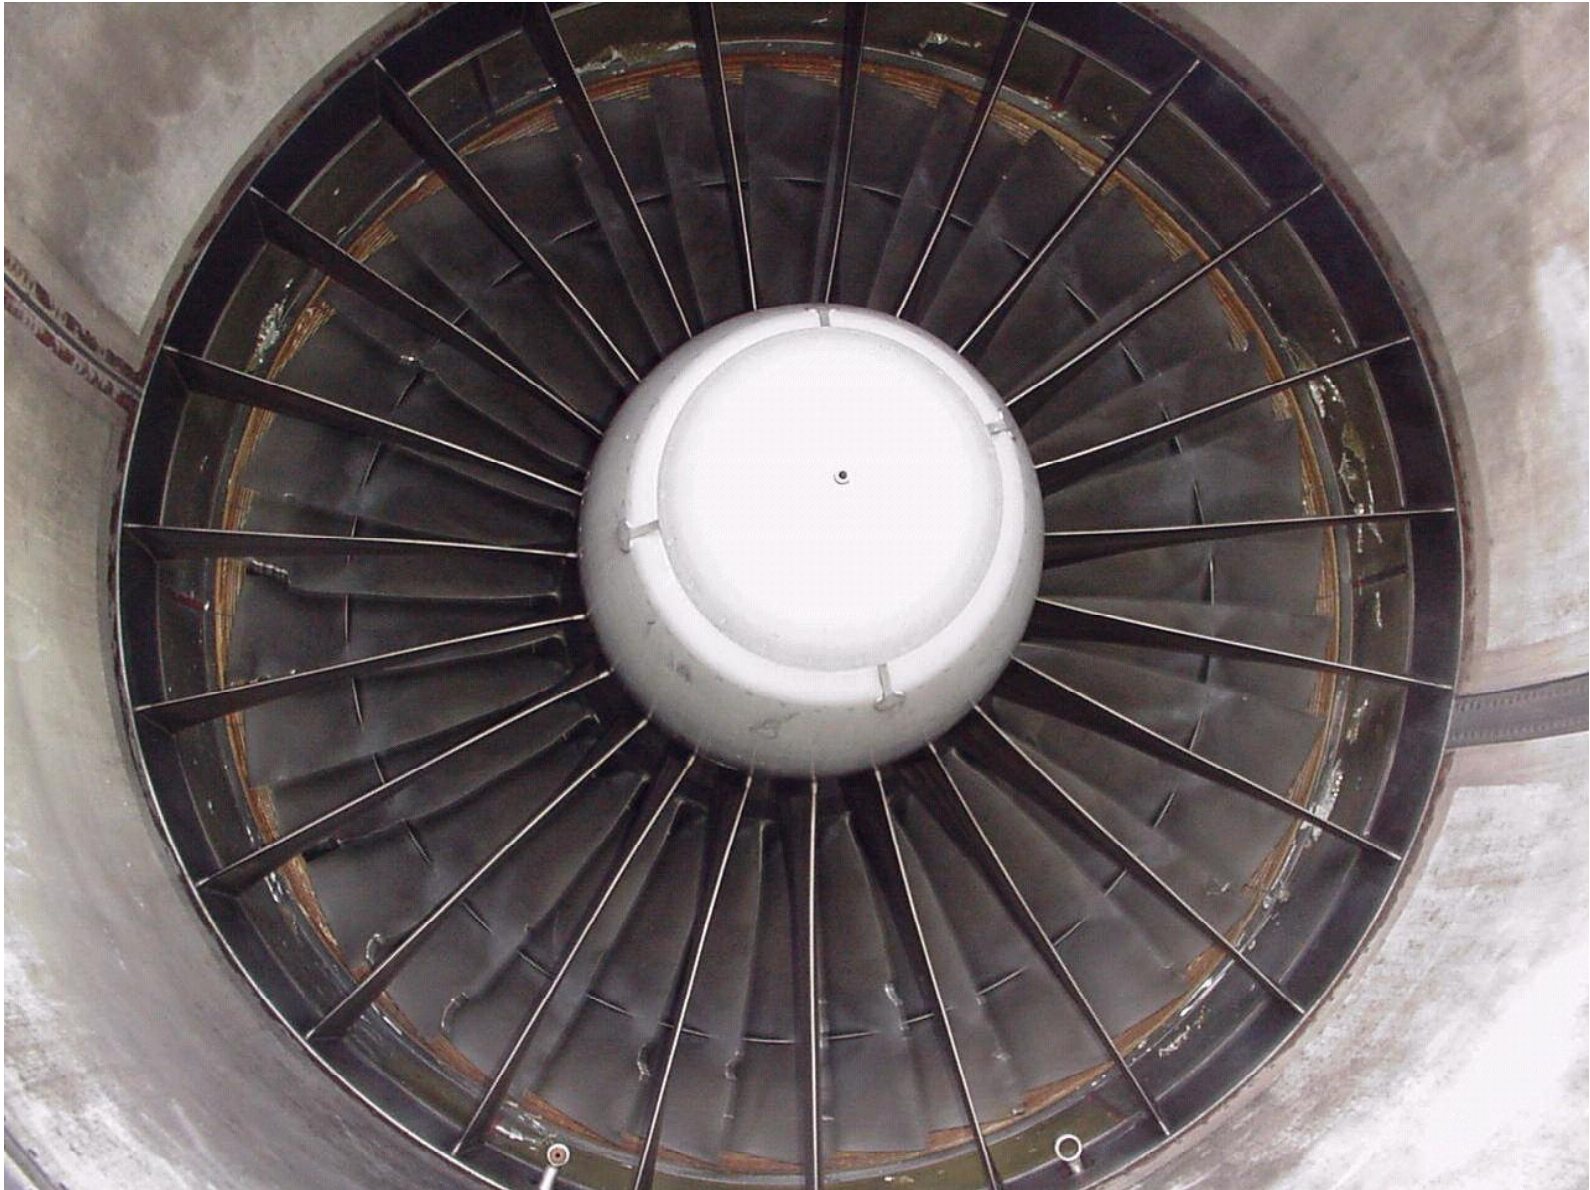
FIGURE 6 Example of damage caused by hard ice. (Courtesy of F.A.S.T.)
